Case study

VIDAR Rids Frequent H2S Induced VFD Failures

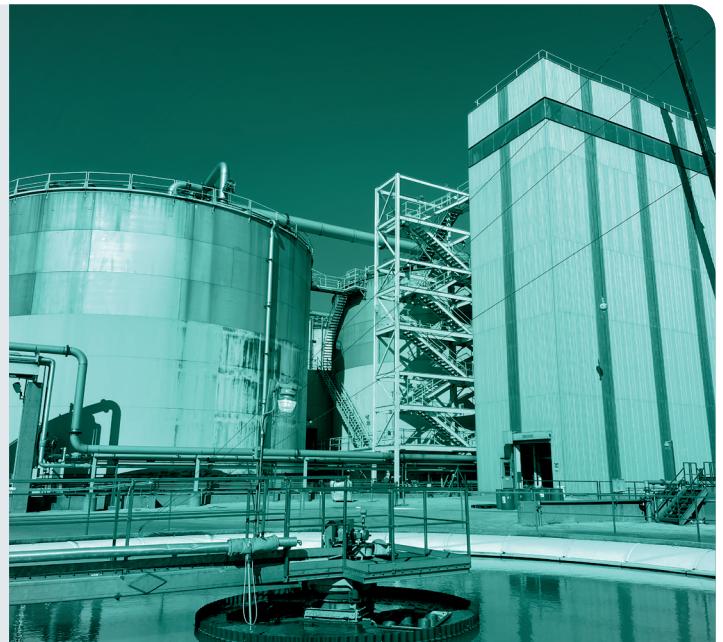
A PLC translated the flow rate of the water into a 4-20mA signal which in turn dictated operating speed. This same PLC would eventually give the same speed reference to a 60HP VIDAR unit.

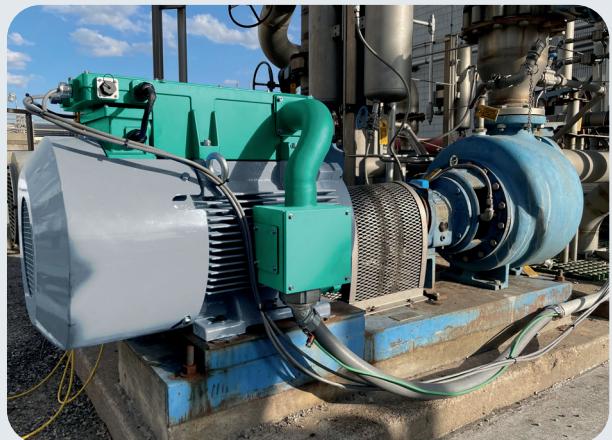
The heat, rain, snow, and corrosive gases couldn't bring it down as the unit operated for the next 14 months without interruption. The unit was removed for teardown analysis (and a replacement installed) which revealed no signs of corrosive damage to either the motor or the power electronics.
